**NEXGEN**  
SURVEYING, LLC.

**LEGAL DESCRIPTION OF: 2160 NW 18 TERRACE, MIAMI, FL, 33125**

LOT 7, LESS THE NORTH 5 FEET, IN BLOCK 2, OF OCOEE PARK, ACCORDING TO THE PLAT THEREOF,. AS RECORDED IN PLAT BOOK 2, AT PAGE 100 OF THE PUBLIC RECORDS OF MIAMI-DADE COUNTY, FLORIDA.

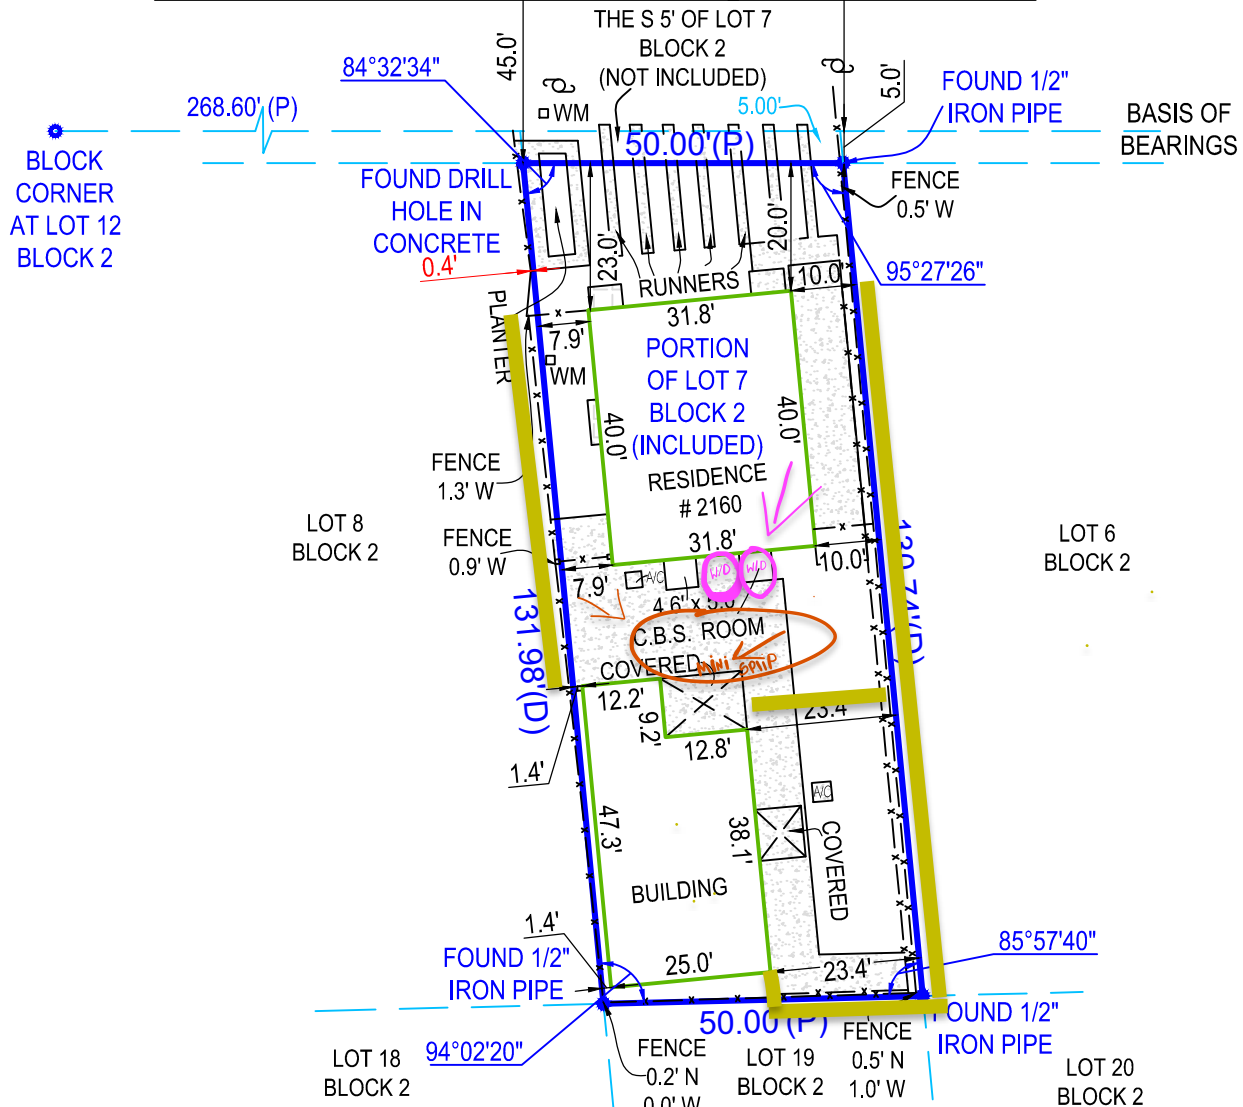
COHUTA AVENUE (PLAT)  
NW 18th TERRACE (FIELD)

23.5' ASPHALT ROADWAY  
80' RIGHT-OF-WAY

- CONCRETE RUNNERS CROSS THE BOUNDARY LINE ON NORTHERLY SIDE OF LOT AS SHOWN.
- CONCRETE WALK CROSS THE BOUNDARY LINE ON WESTERLY SIDE OF LOT AS SHOWN.
- FENCES LIE NEAR BOUNDARY LINES AS SHOWN, OWNERSHIP NOT DETERMINED.
